Report No.: HLN0127/2009

SUPERSEN BRACKET

Tensile strength test

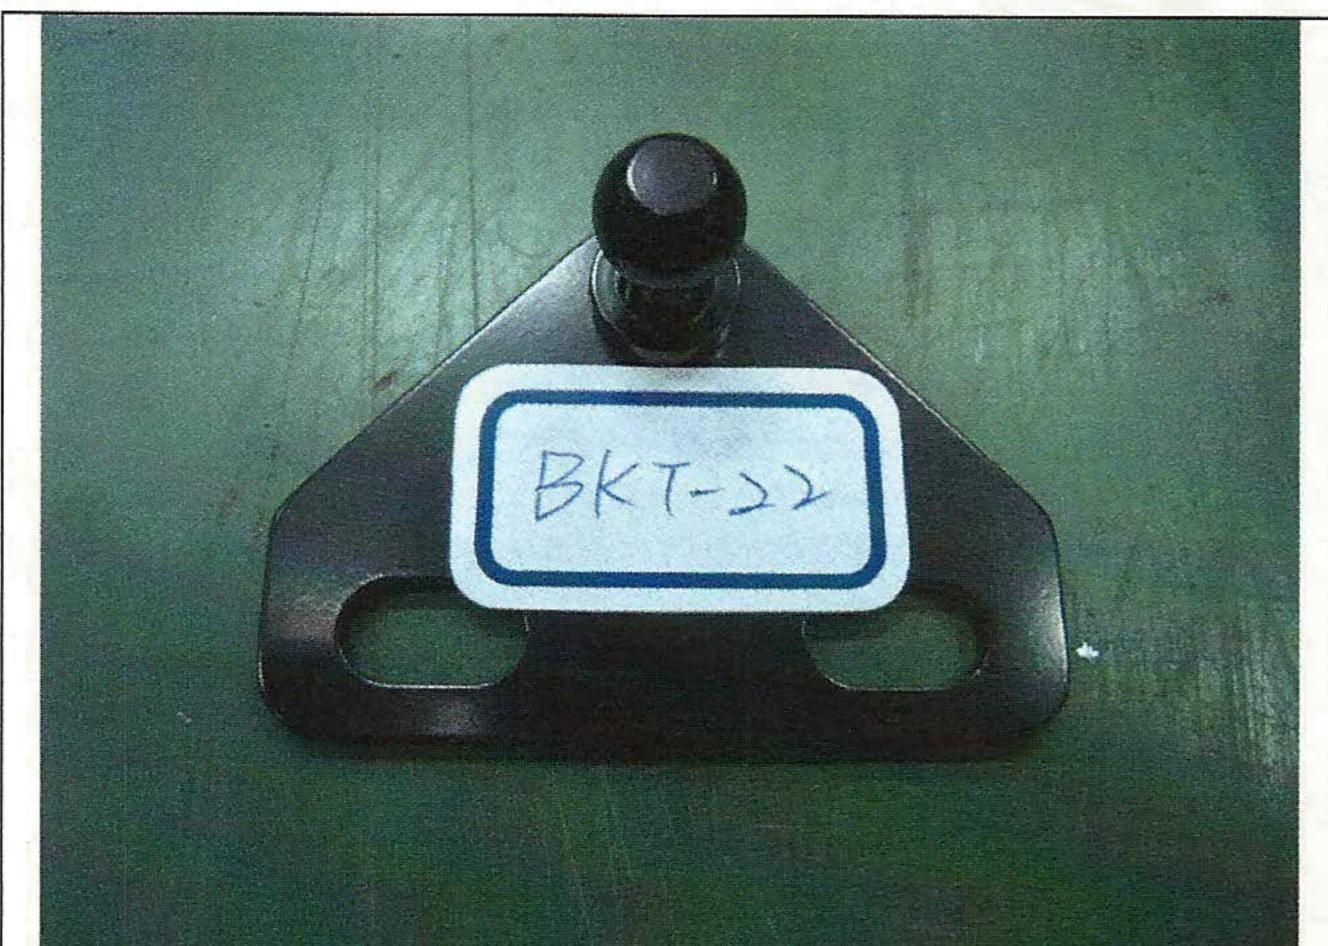
Photo "A" (Appearance of sample) BKT-22

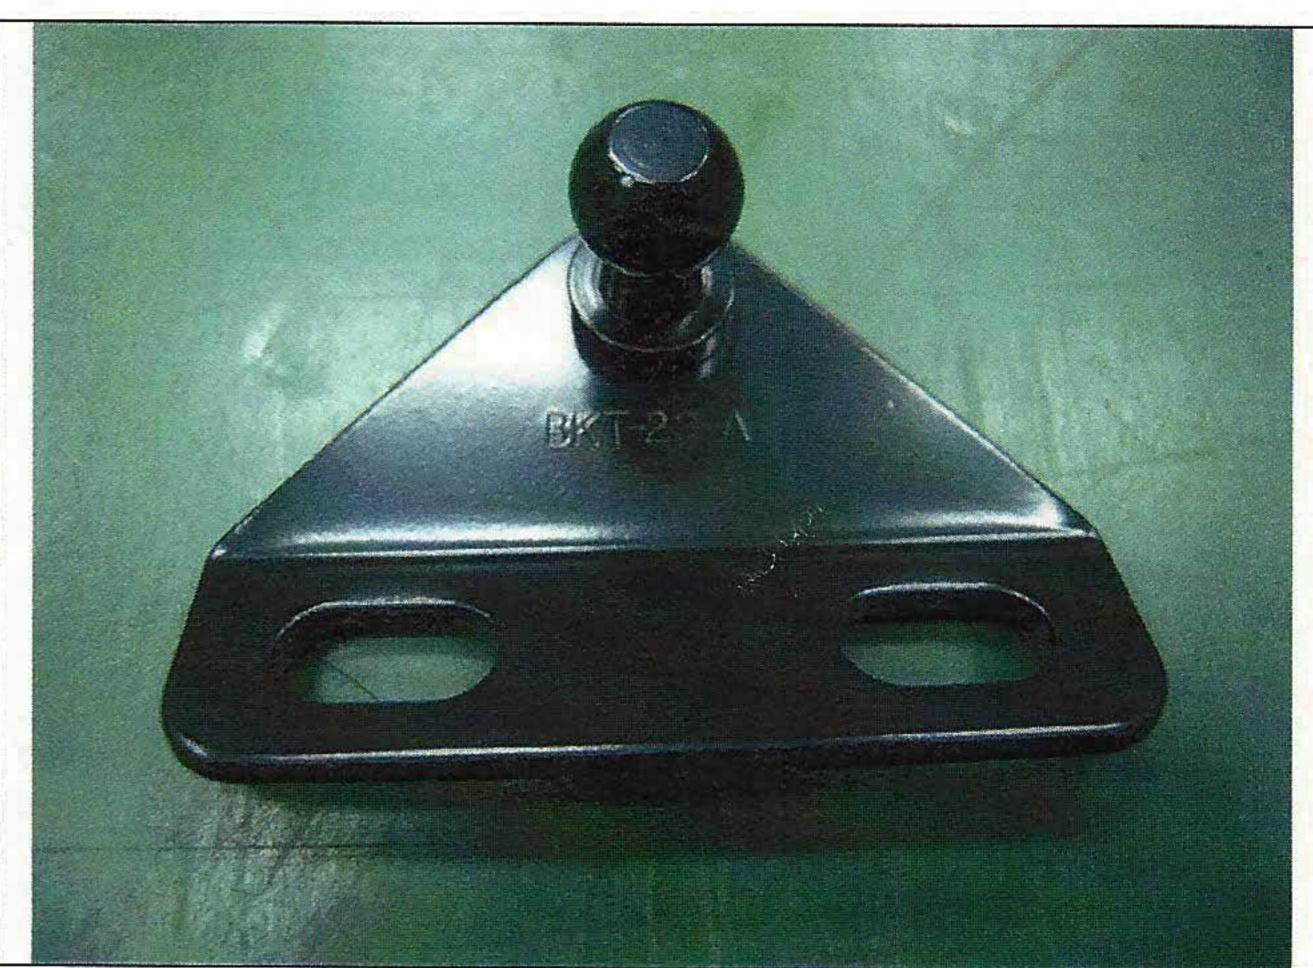
Photo "B" (Appearance of sample) BKT-22-A

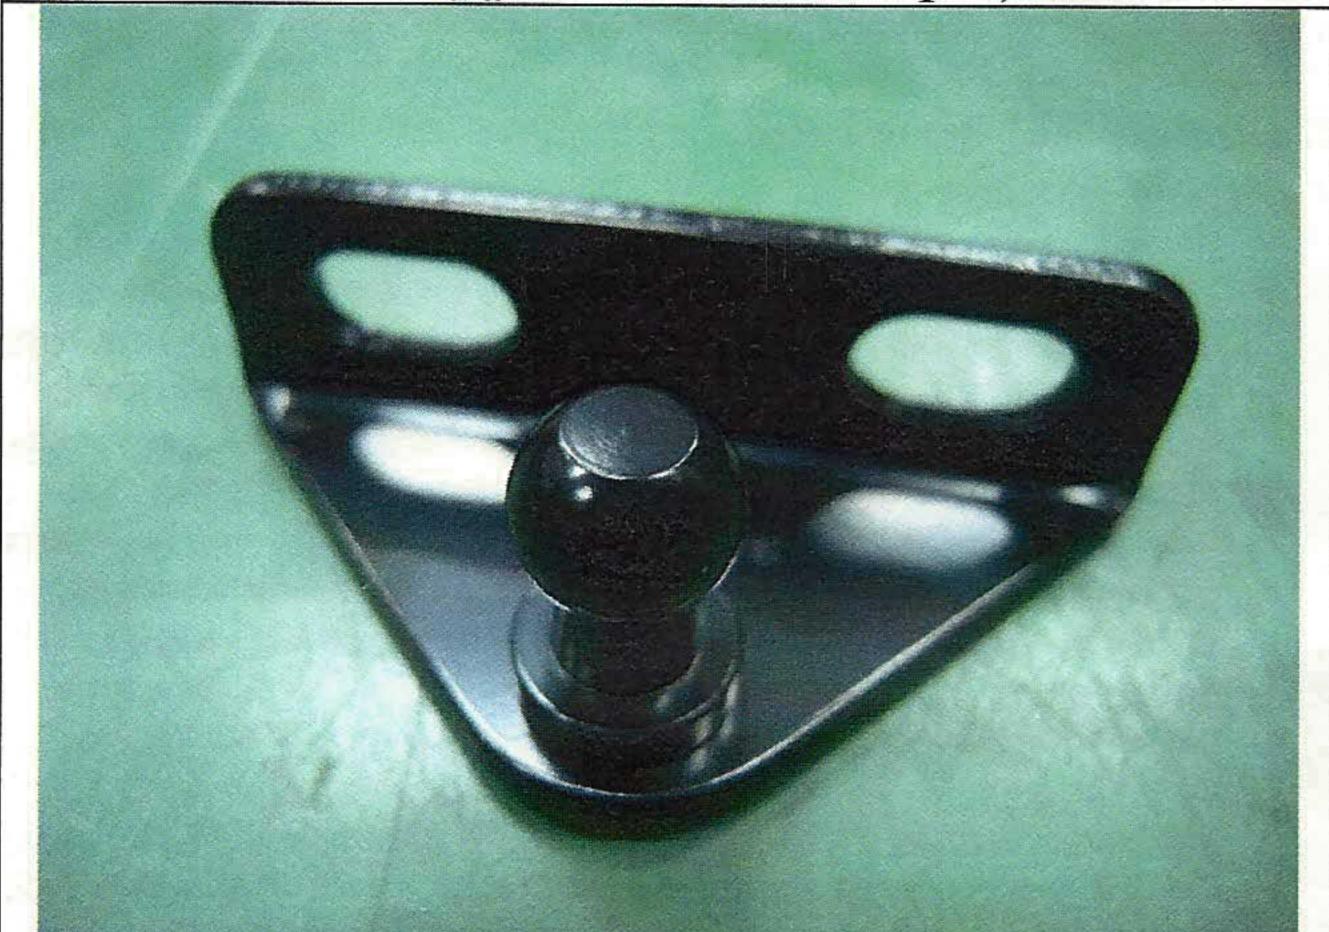
Photo "C" (Appearance of sample) BKT-22-I

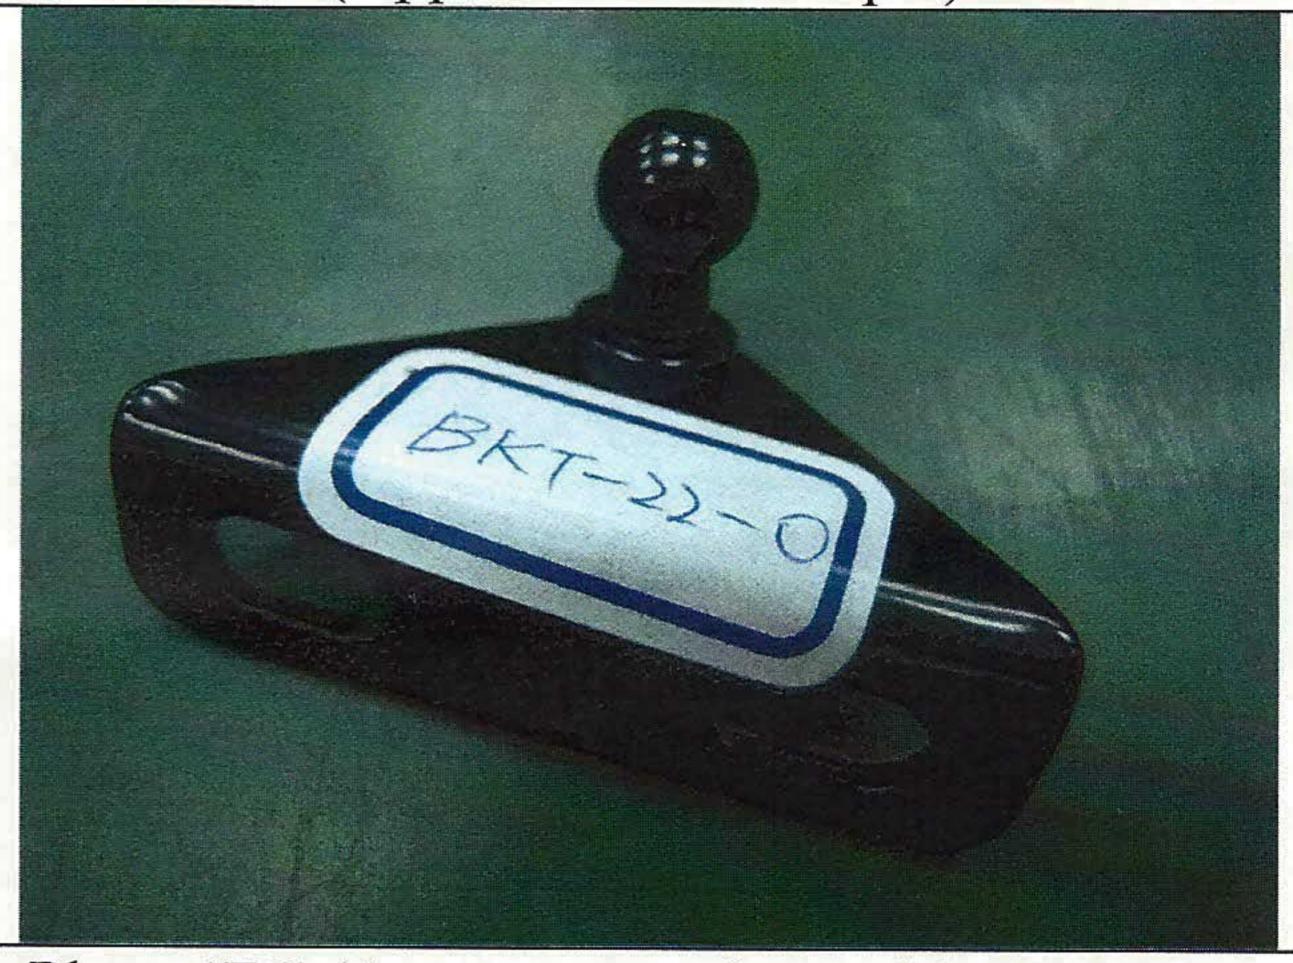
Photo "D" (Appearance of sample) BKT-22-O

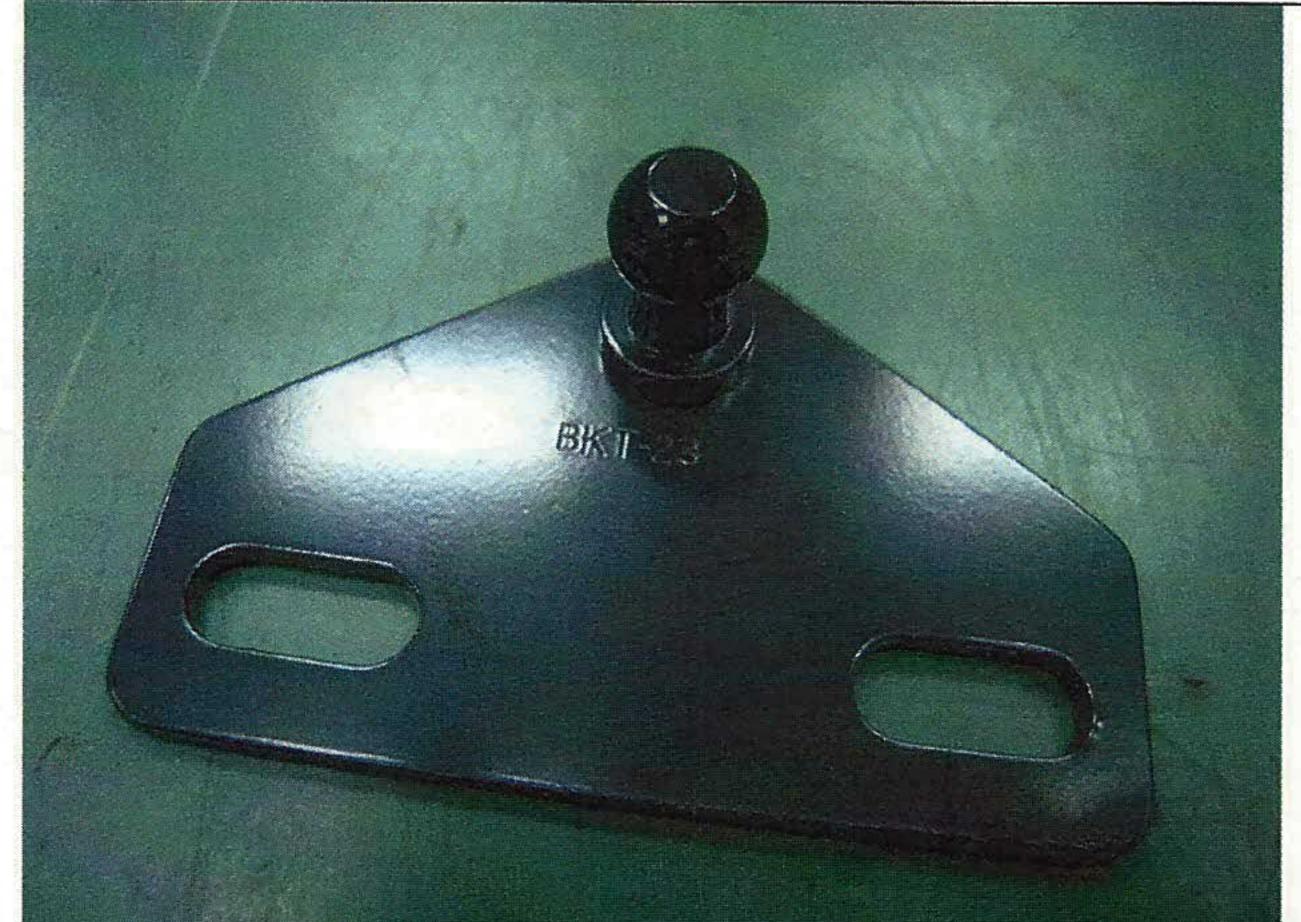
Photo "E" (Appearance of sample) BKT-23

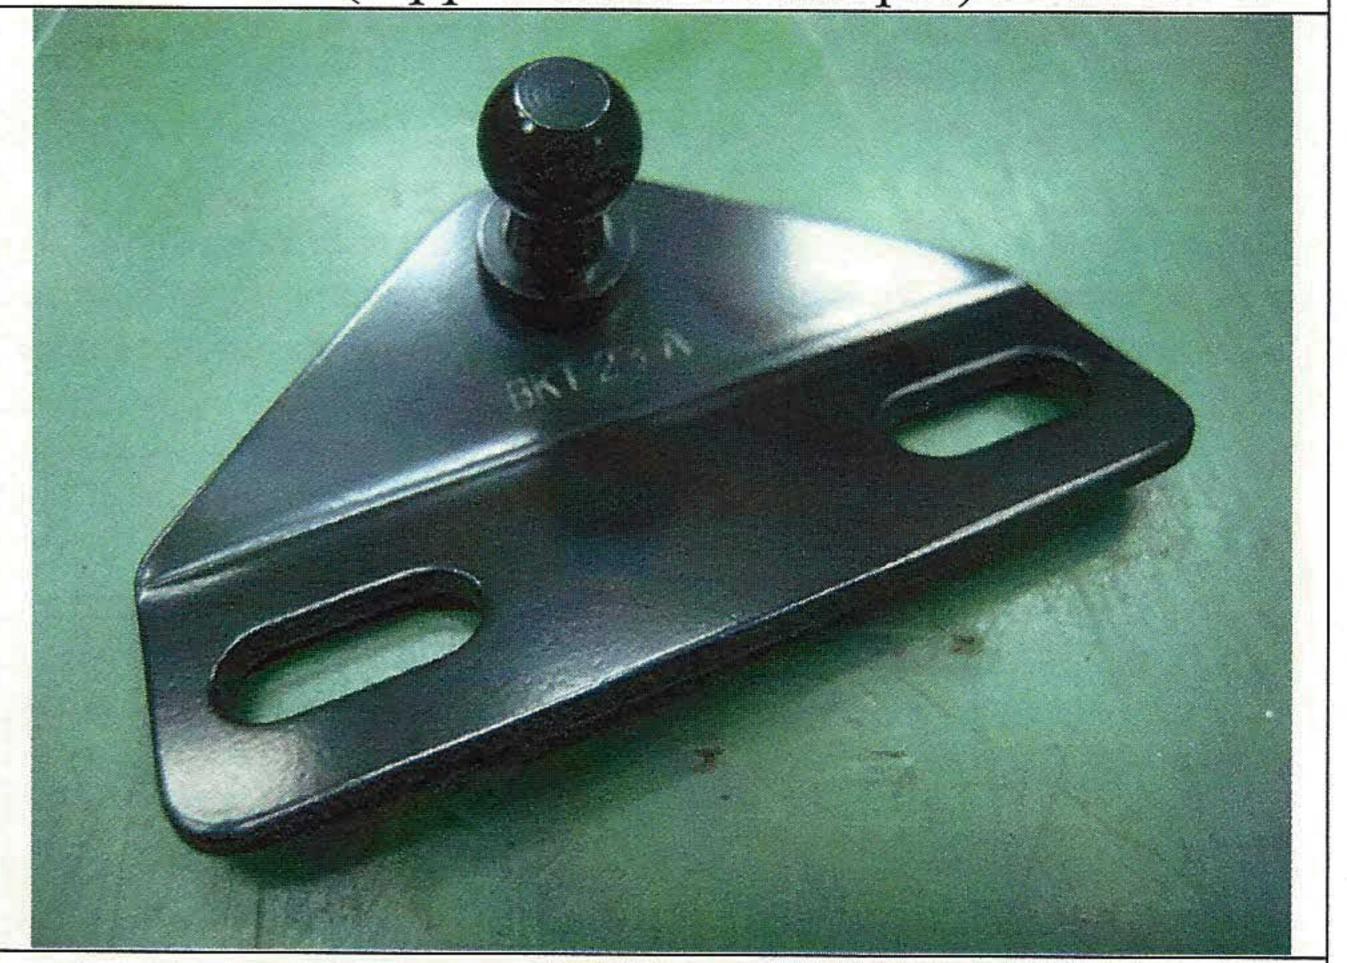
Photo "F" (Appearance of sample) BKT-23-A

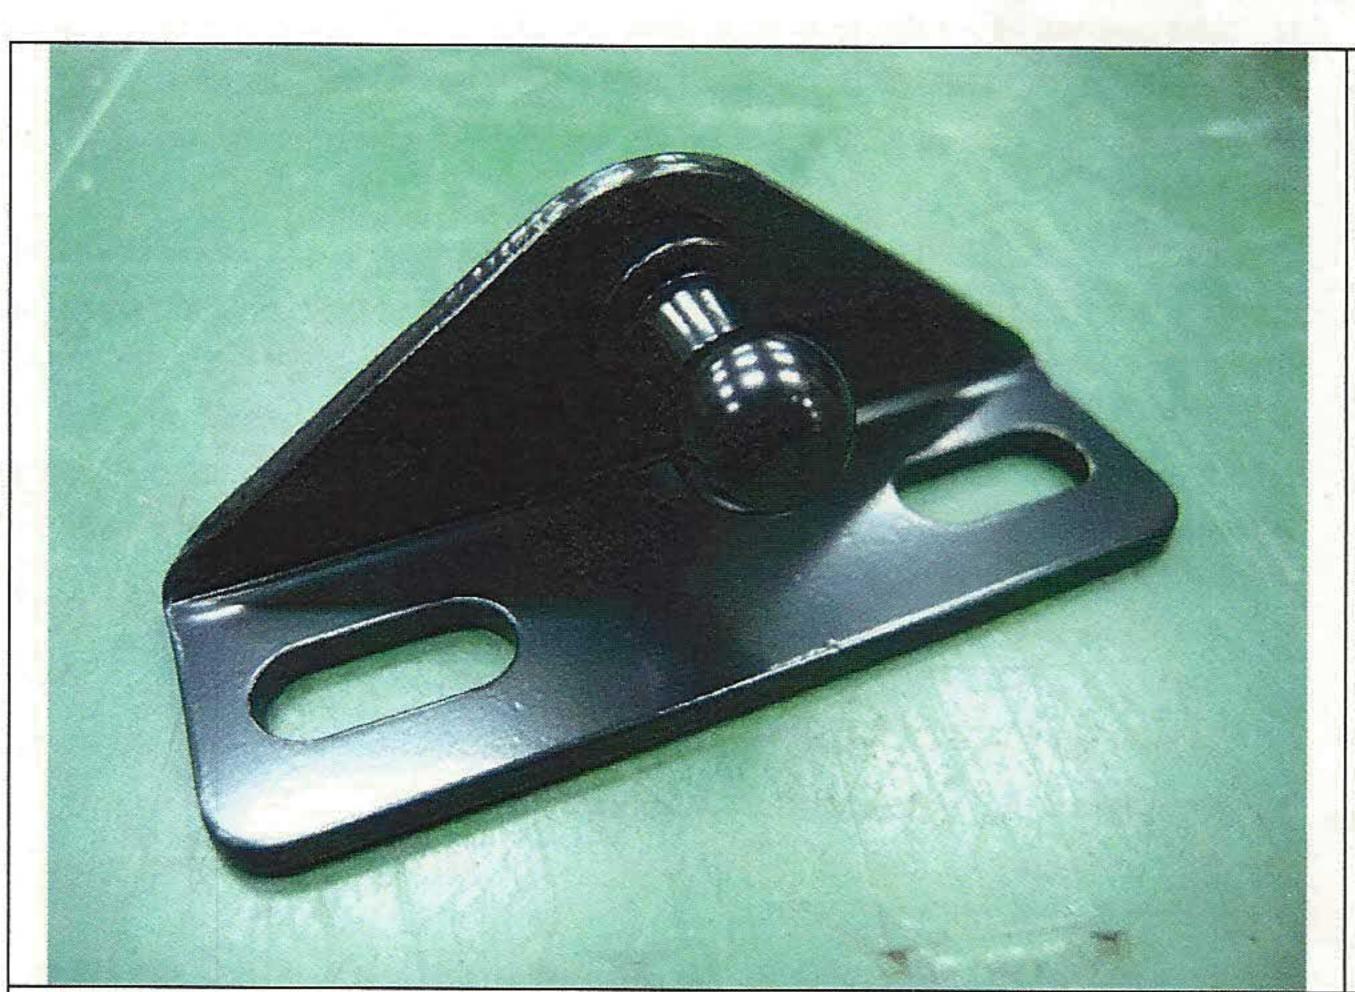
Photo "G" (Appearance of sample) BKT-23-I

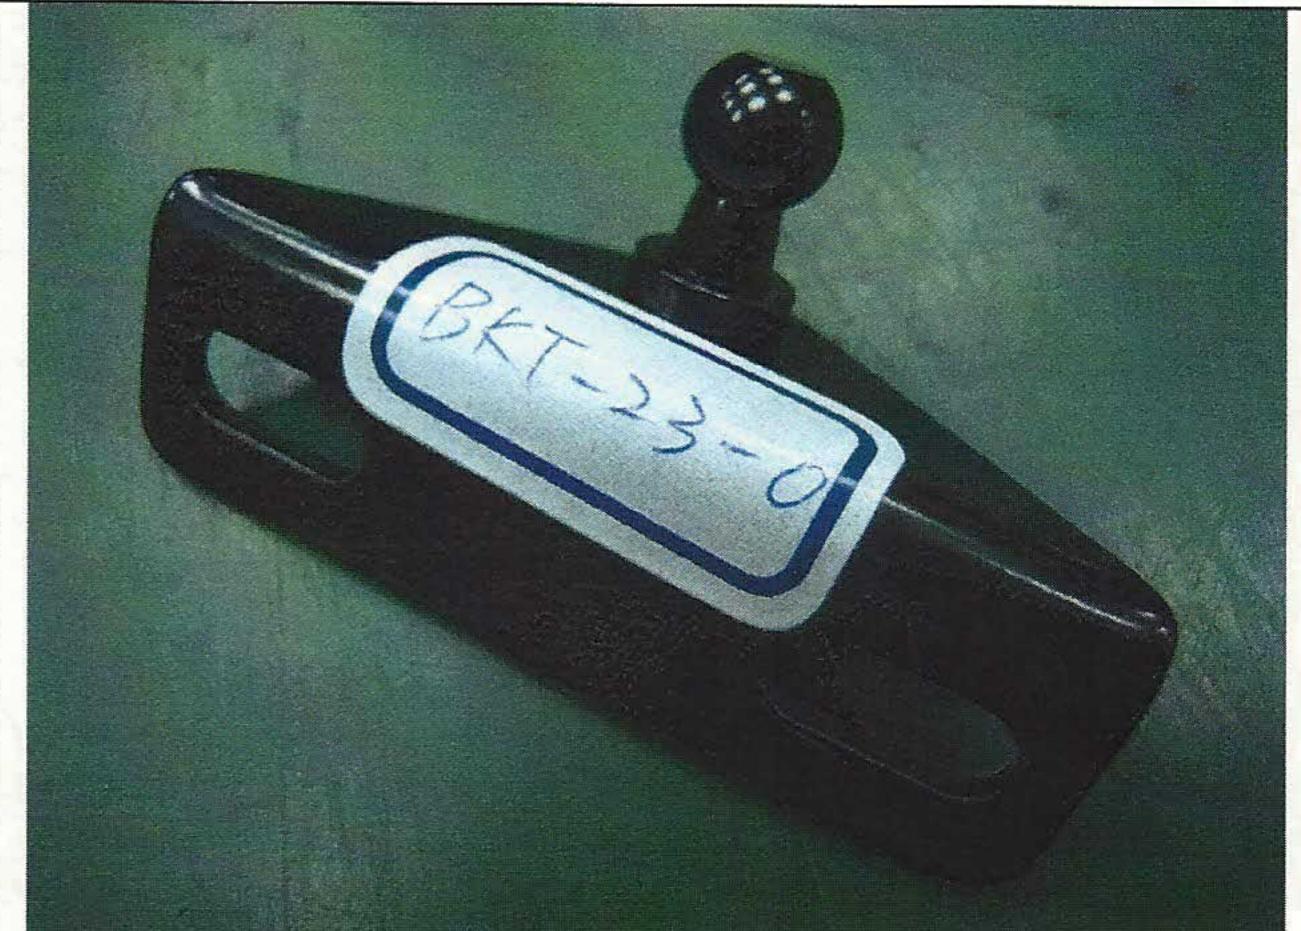
Photo "H" (Appearance of sample) BKT-23-O

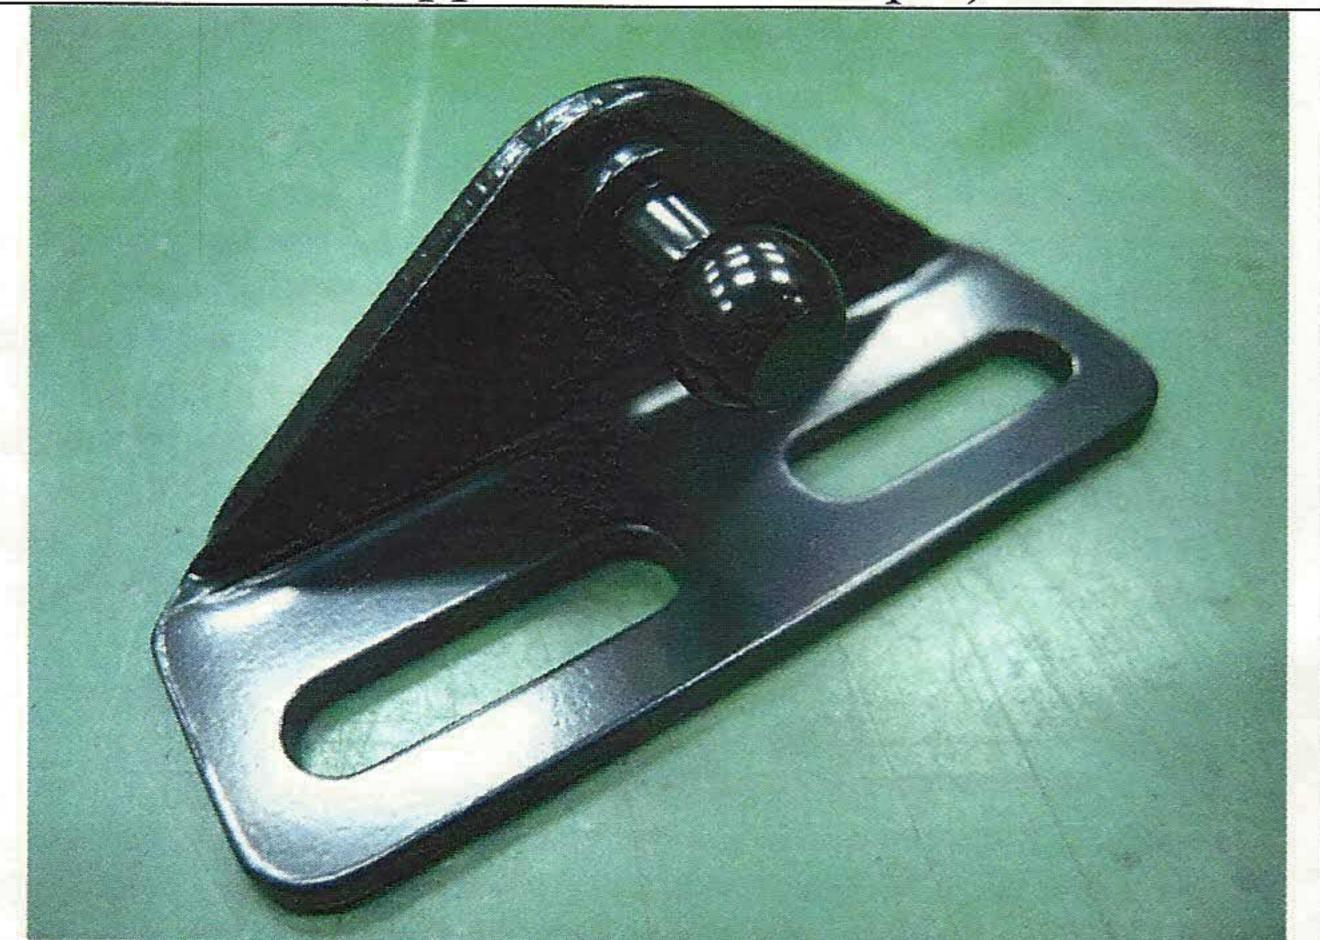
Photo "I" (Appearance of sample) BKT-24-I

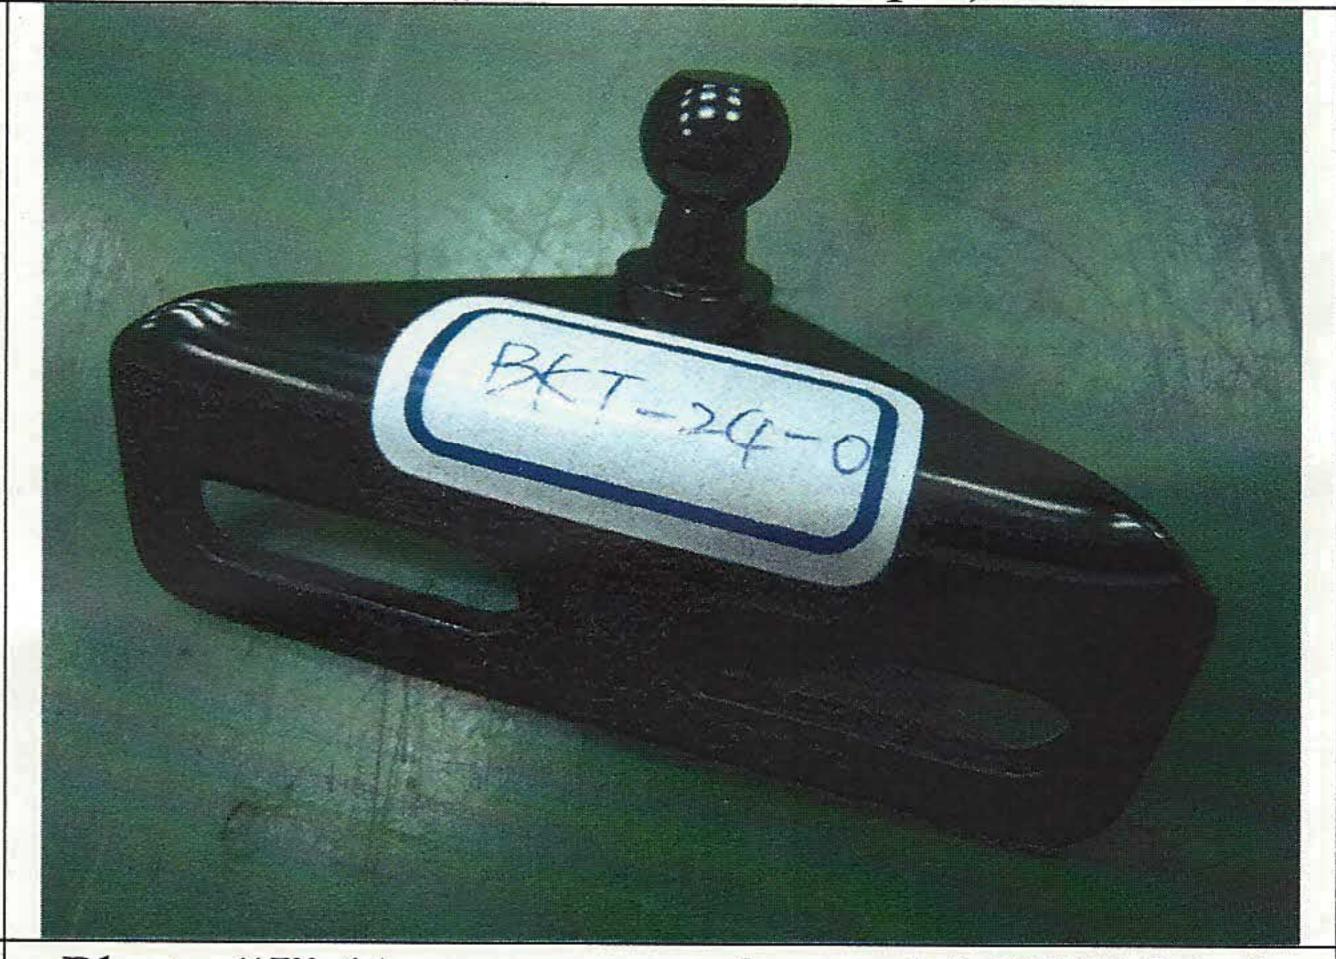
Photo "J" (Appearance of sample) BKT-24-O

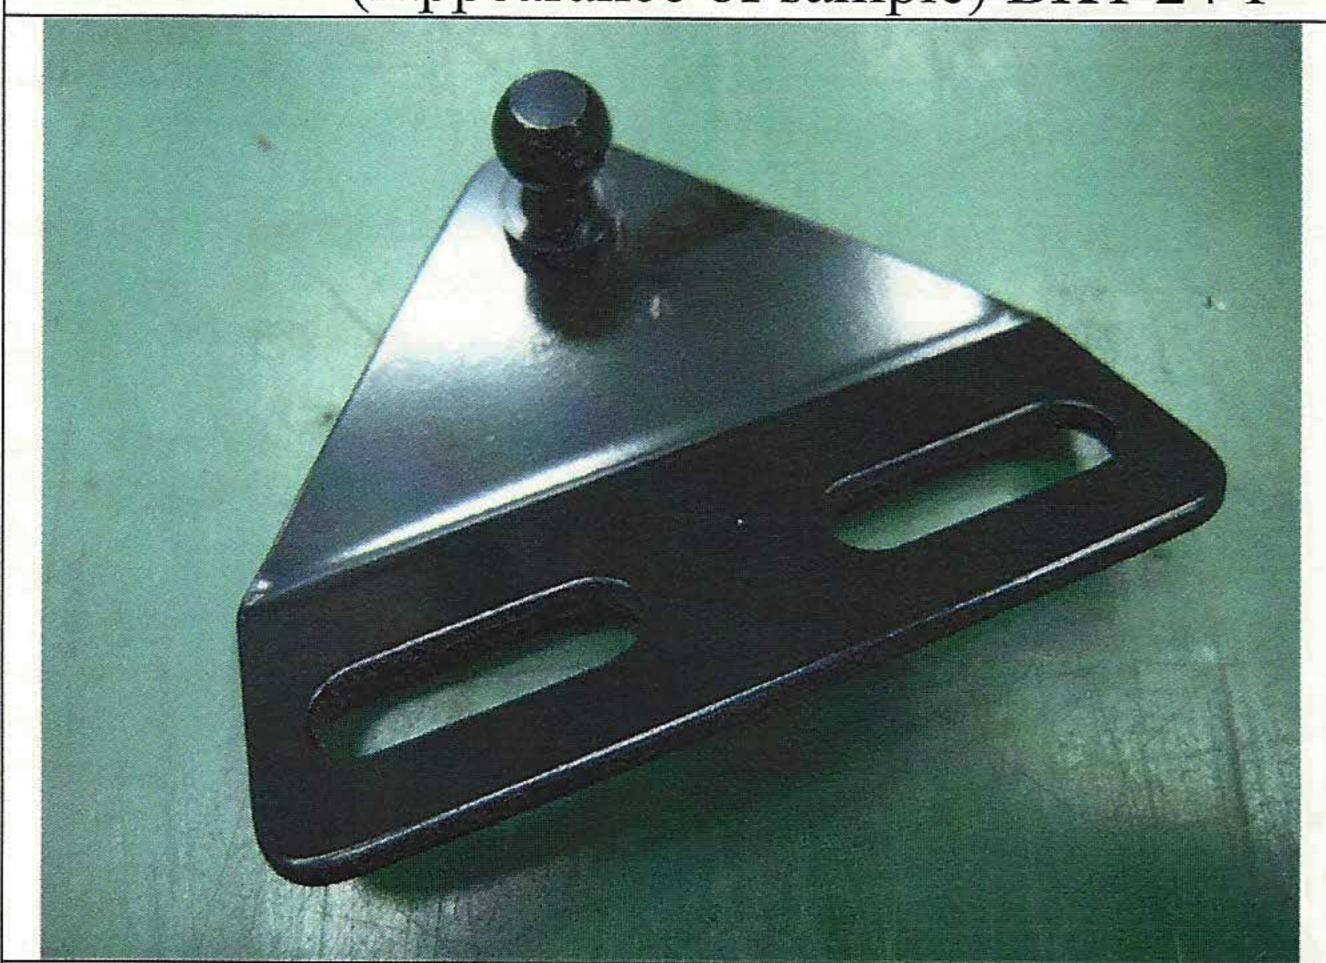
Photo "K" (Appearance of sample) BKT-25-A

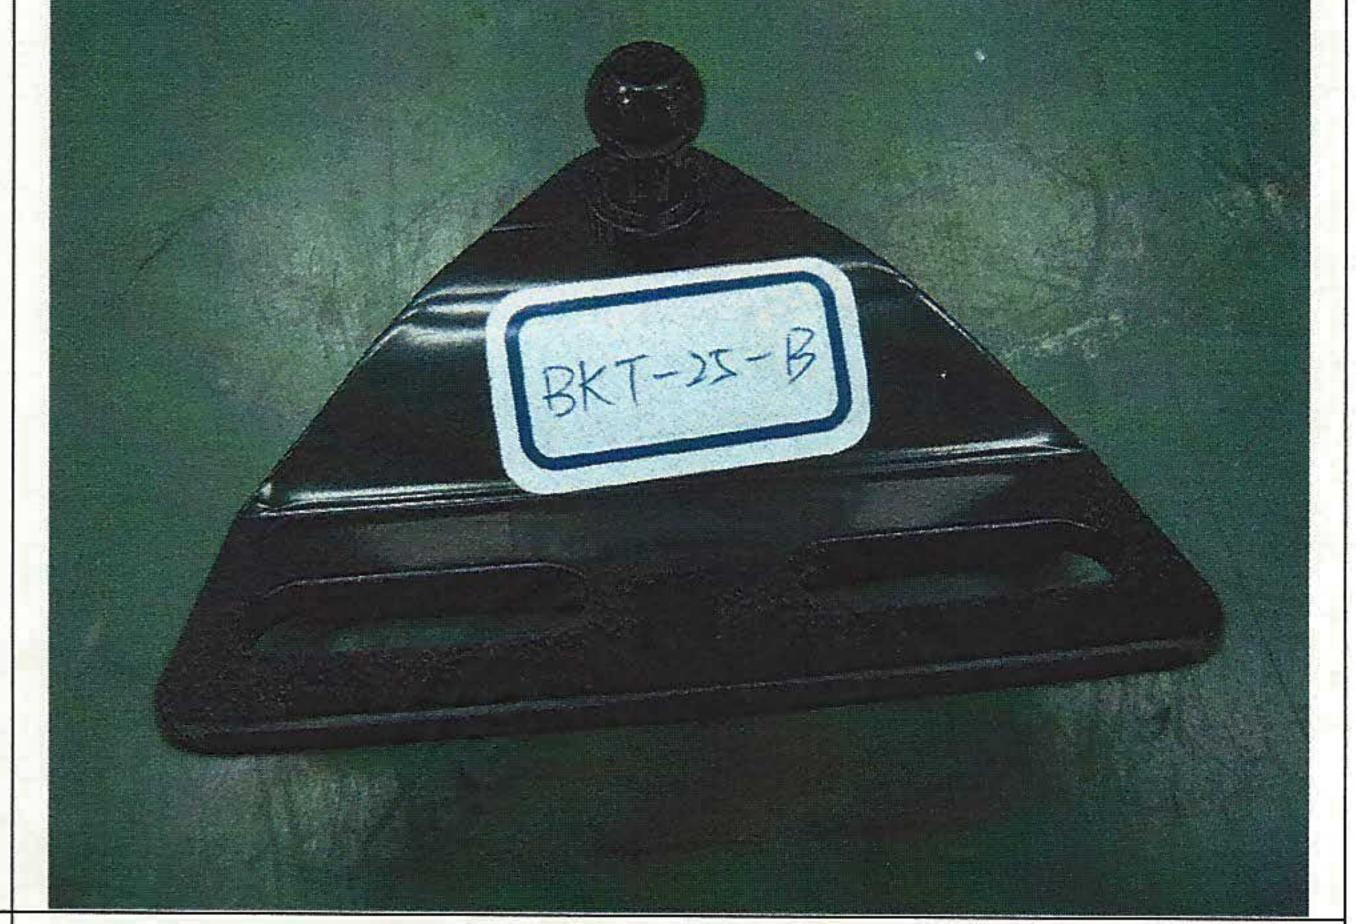
Photo "L" (Appearance of sample) BKT-25-B

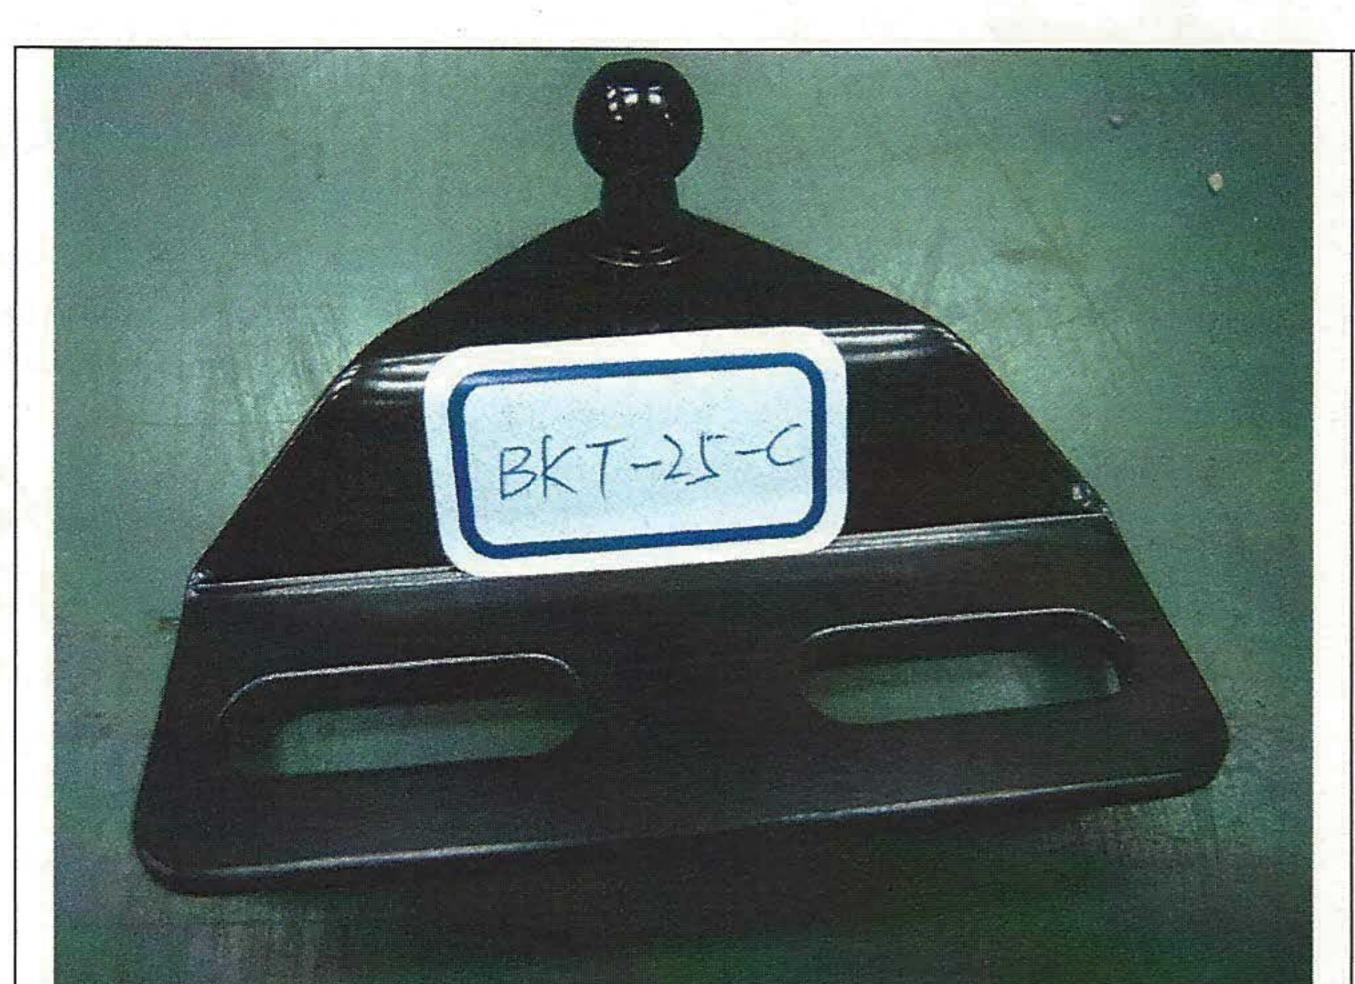
Photo "M" (Appearance of sample) BKT-25-C

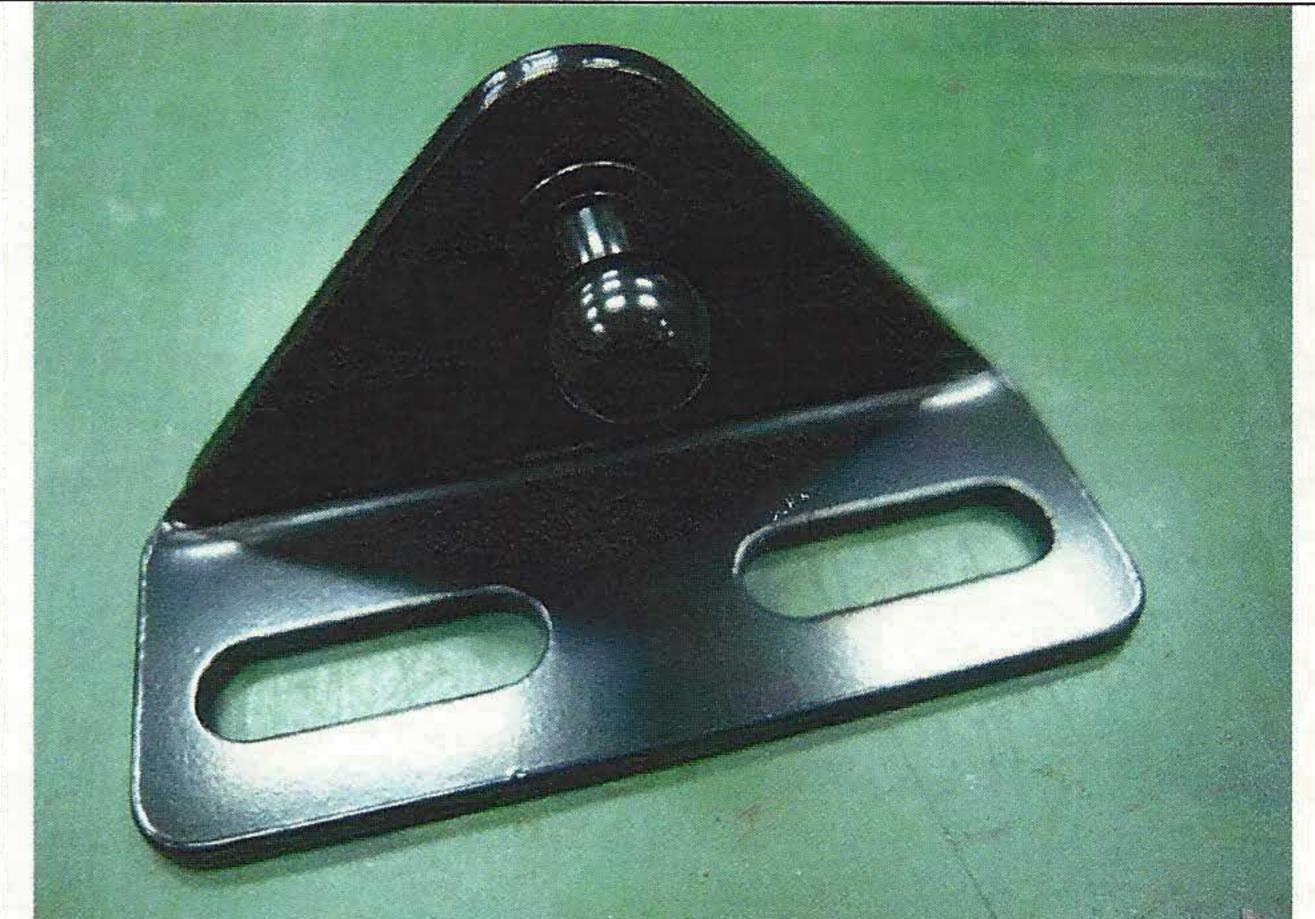
Photo "N" (Appearance of sample) BKT-25-I

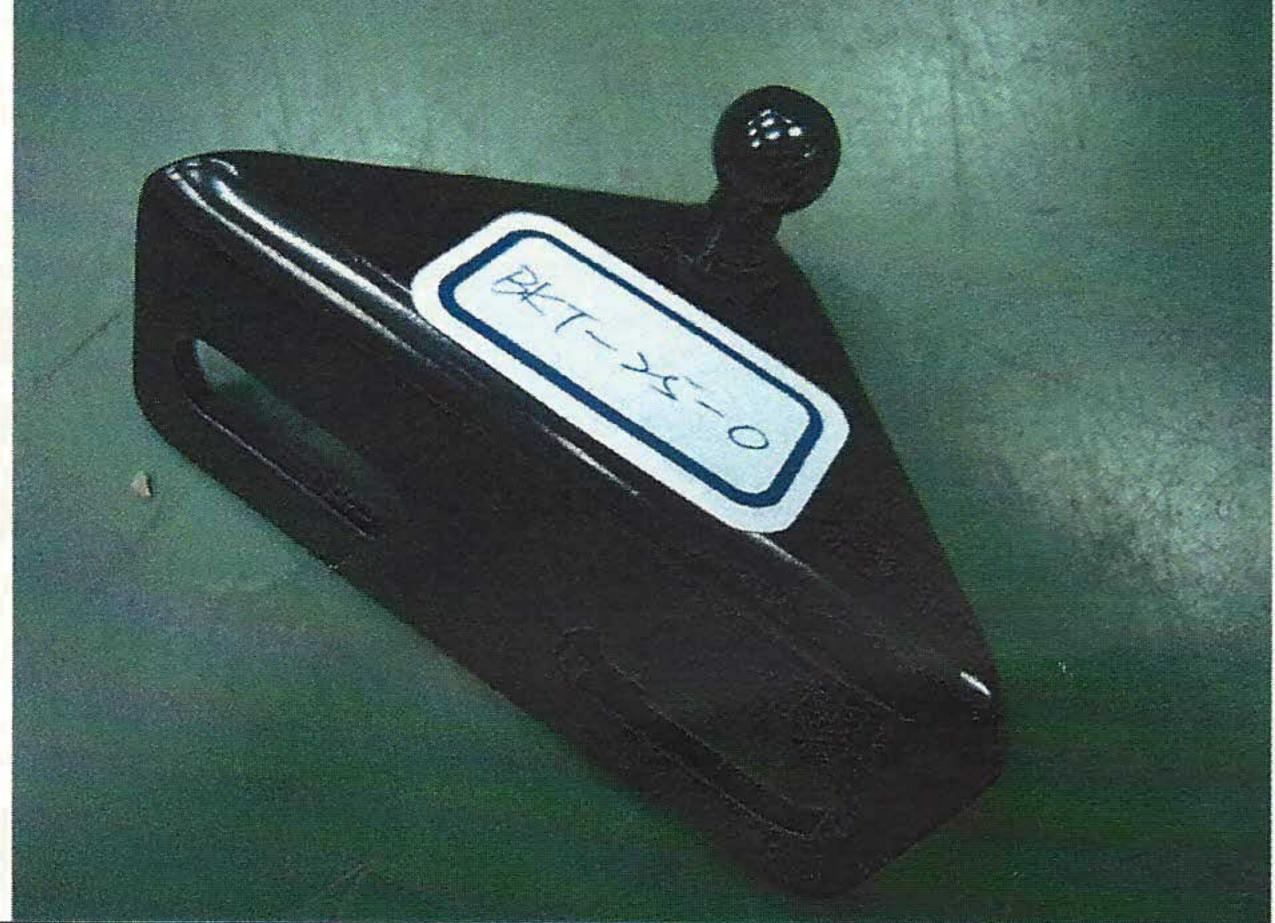
Photo "O" (Appearance of sample) BKT-25-O

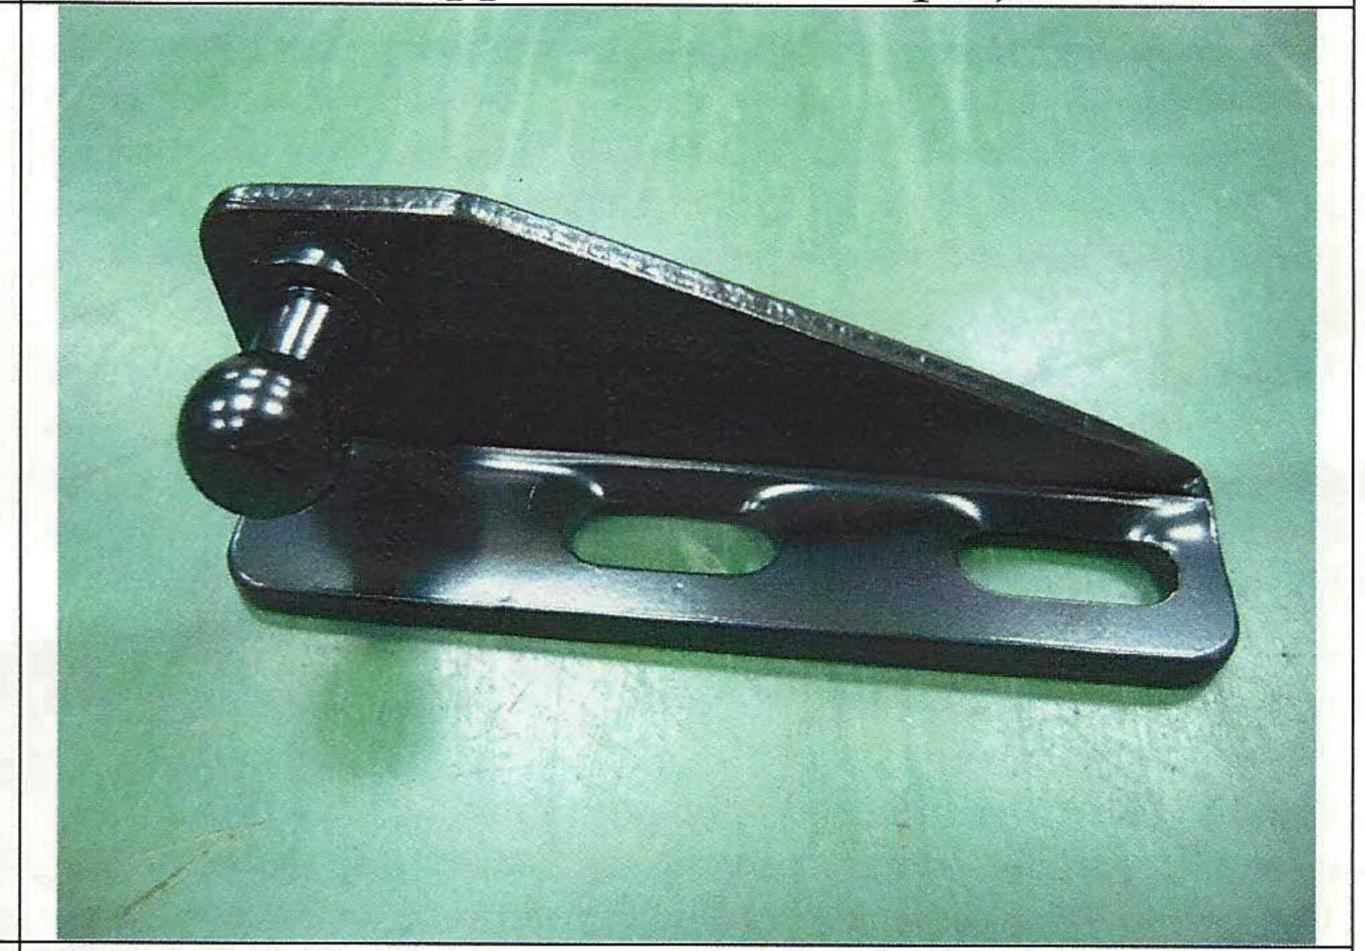
Photo "P" (Appearance of sample) BKT-26-L

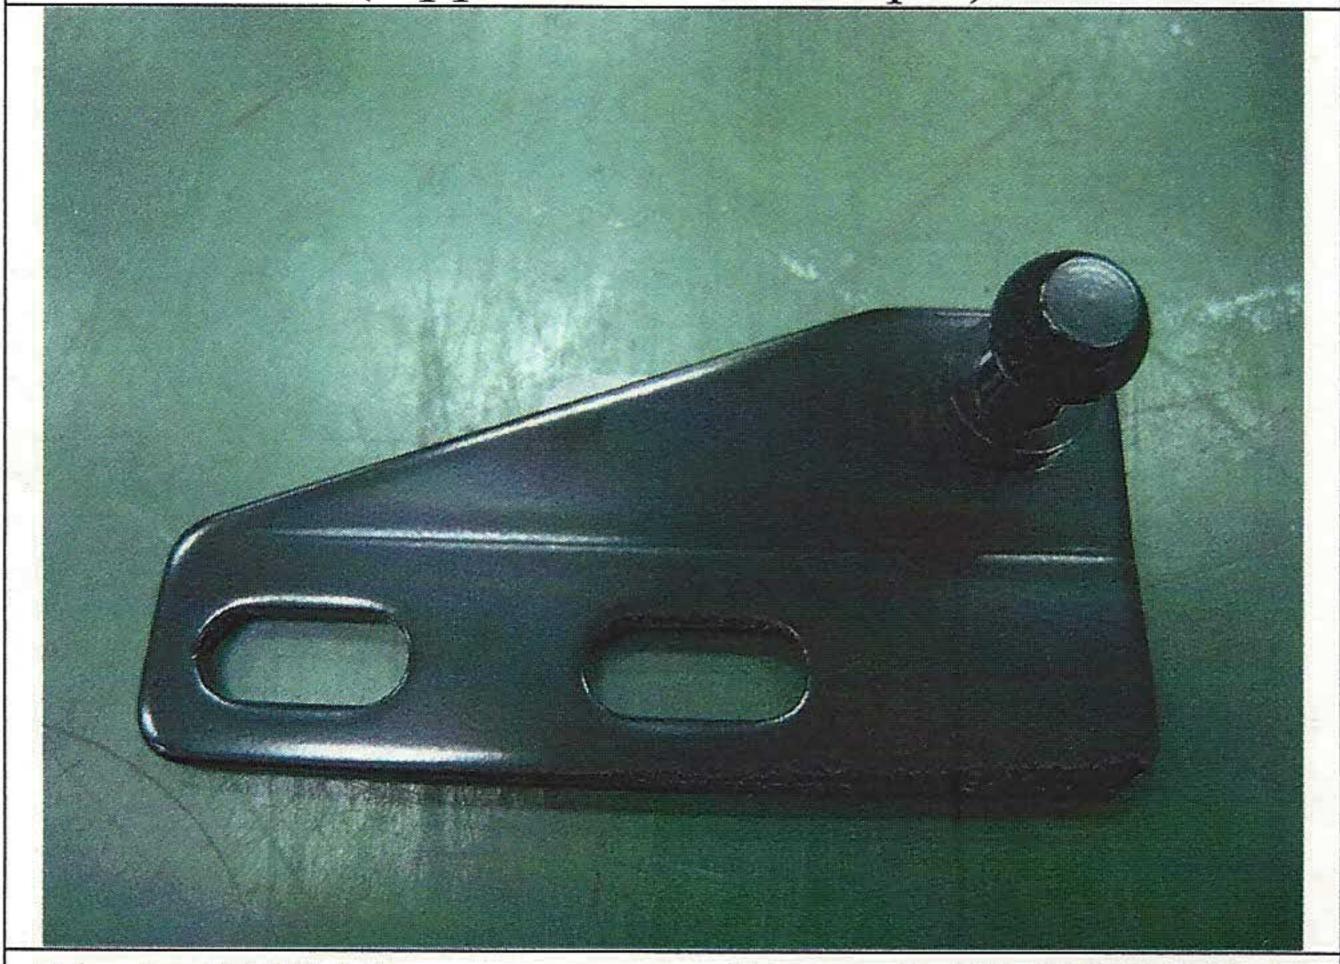
Photo "Q" (Appearance of sample)BKT-26-LA

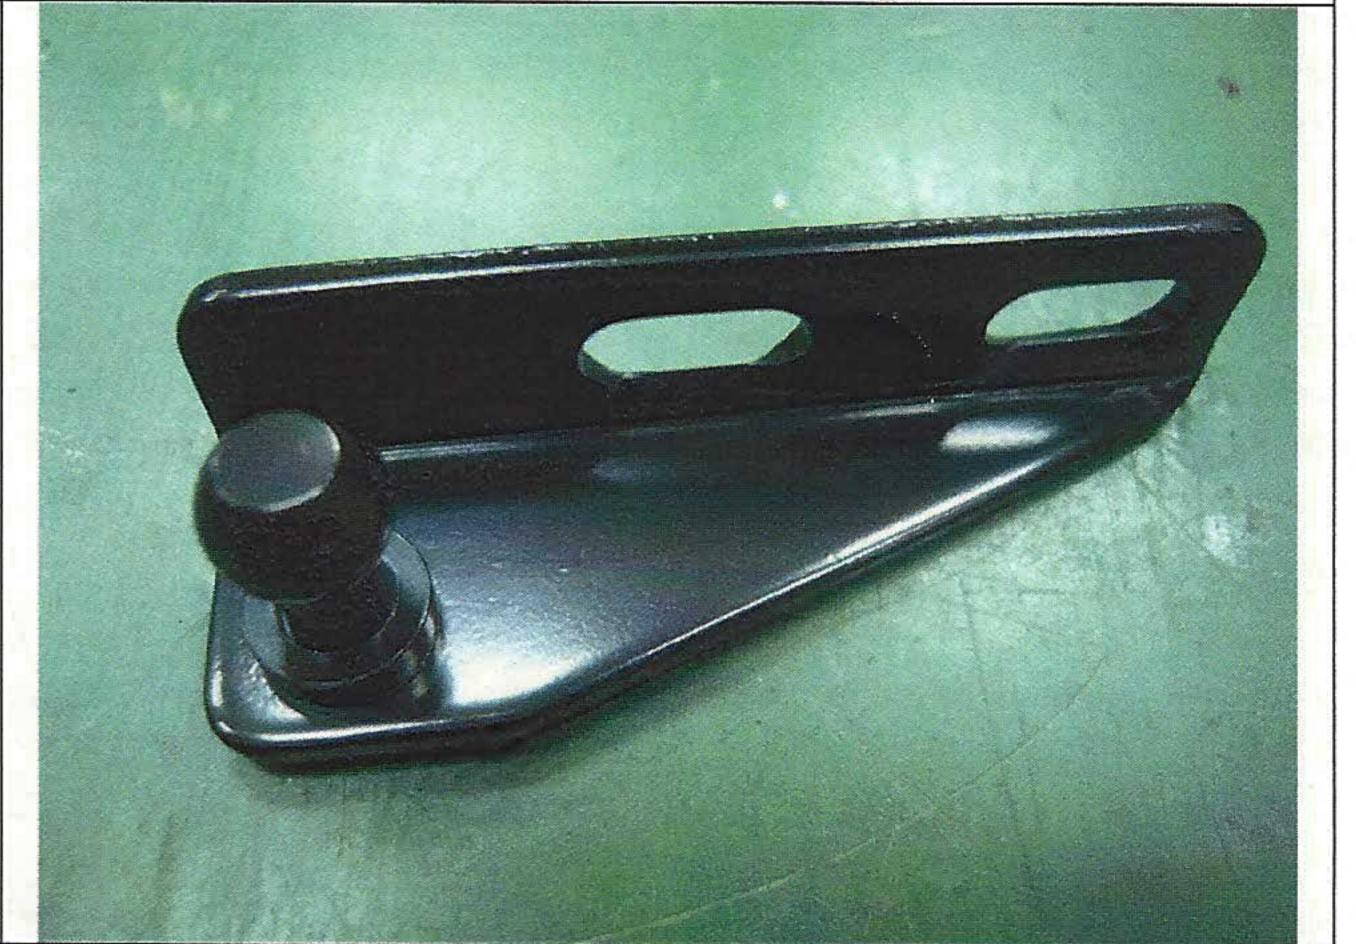
Photo "R" (Appearance of sample) BKT-26-R
