Report No.: HLN0127/2009

SUPERSEN BRACKET

Tensile strength test

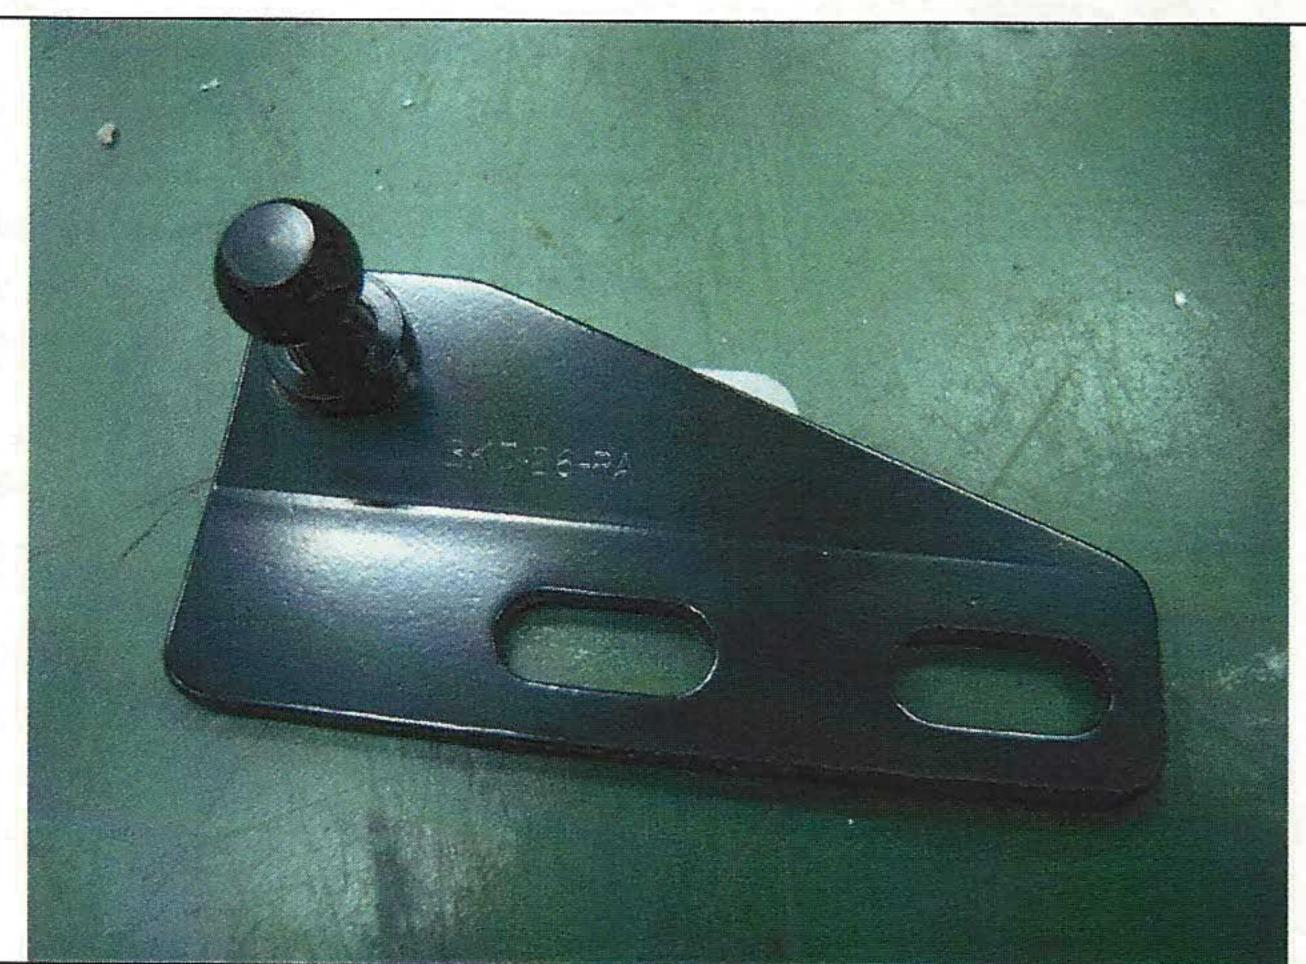
Photo "S" (Appearance of sample) BKT-26-RA

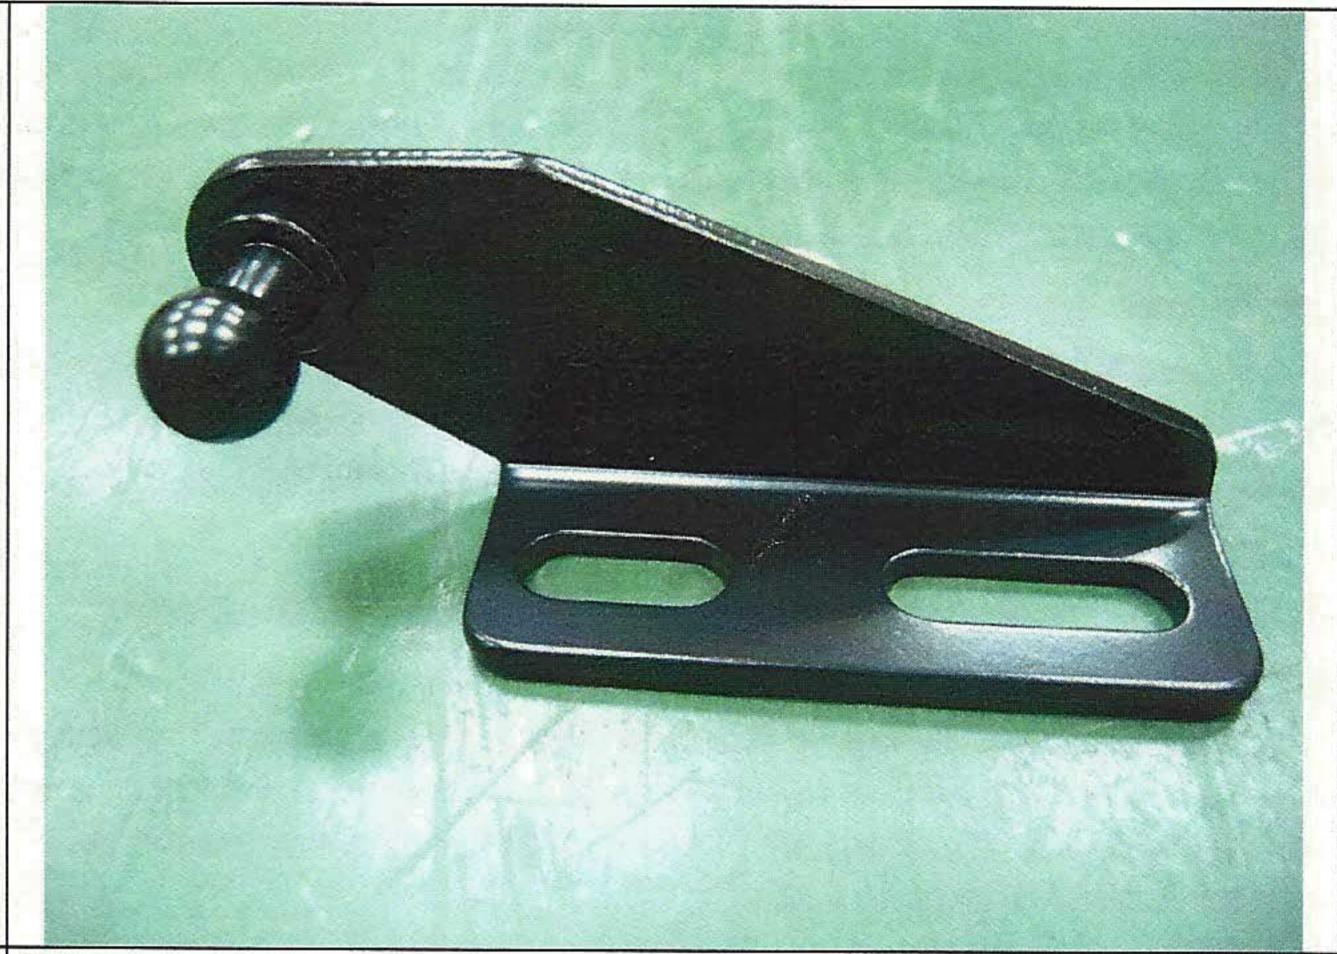
Photo "T" (Appearance of sample) BKT-27-L

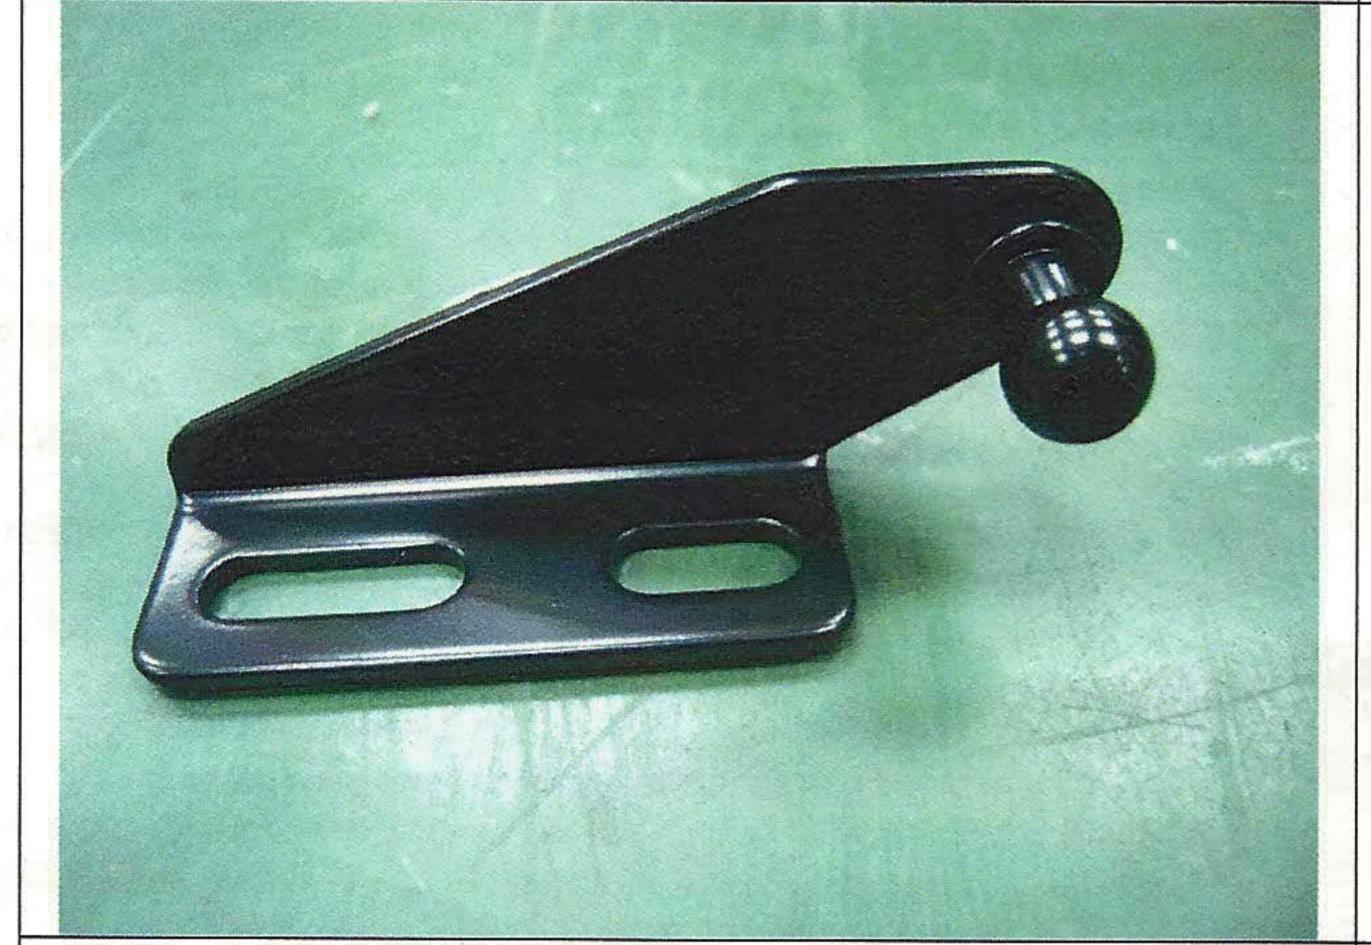
Photo "U" (Appearance of sample) BKT-27-R

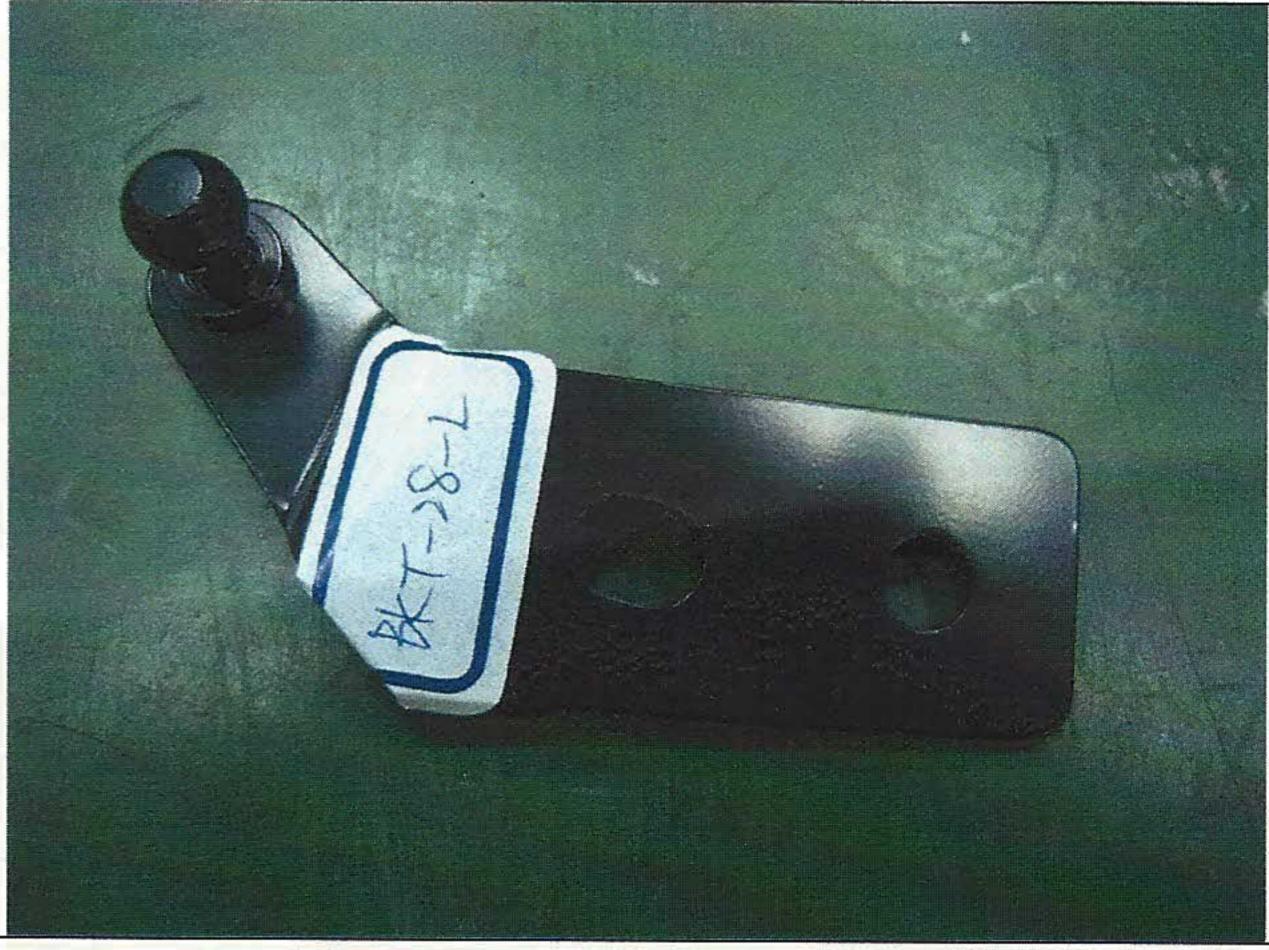
Photo "V" (Appearance of sample) BKT-28-L

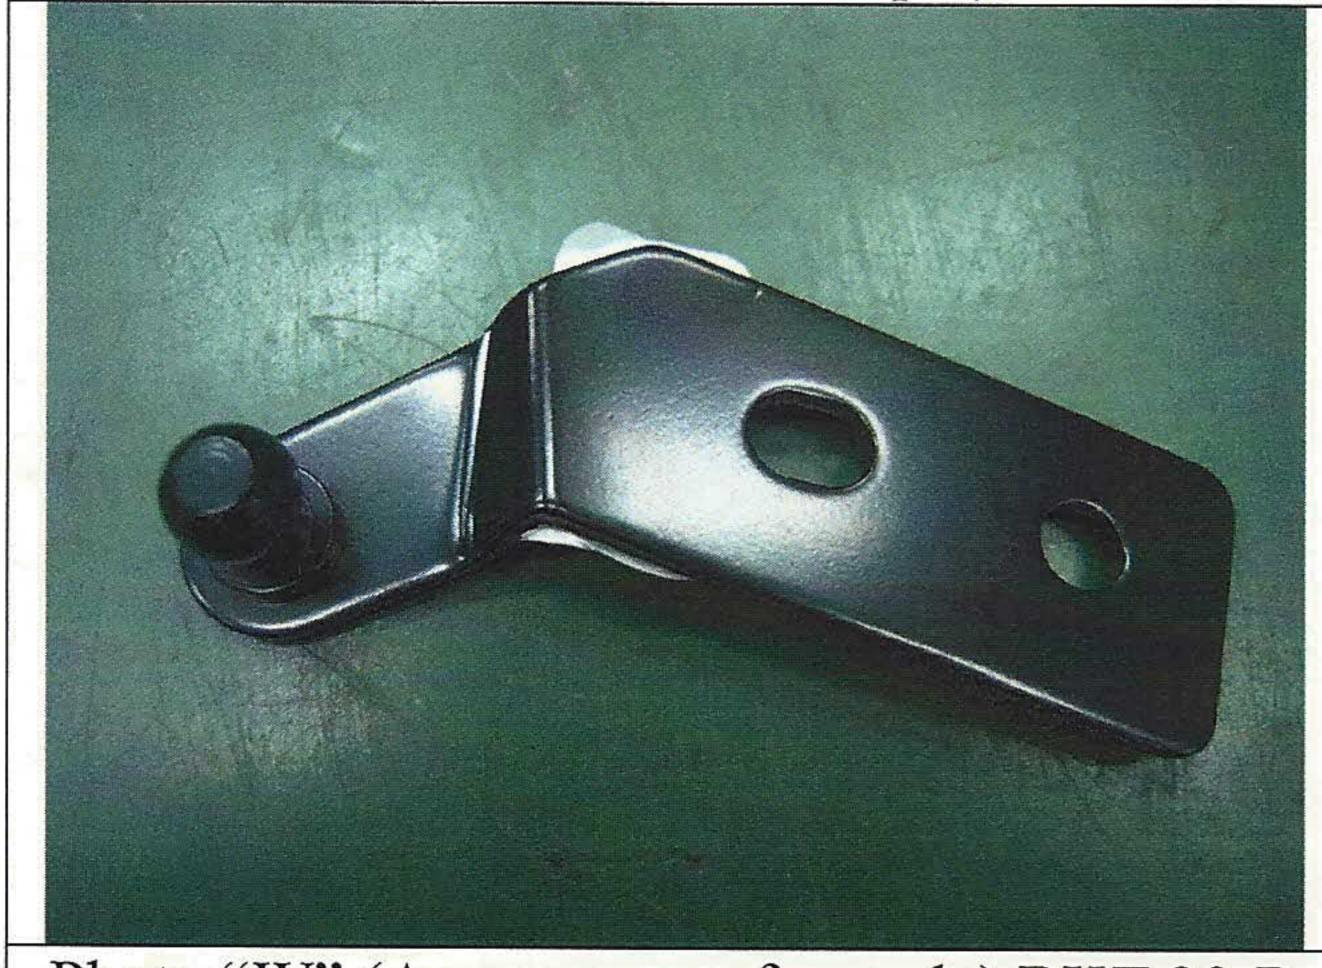
Photo "W" (Appearance of sample) BKT-28-R

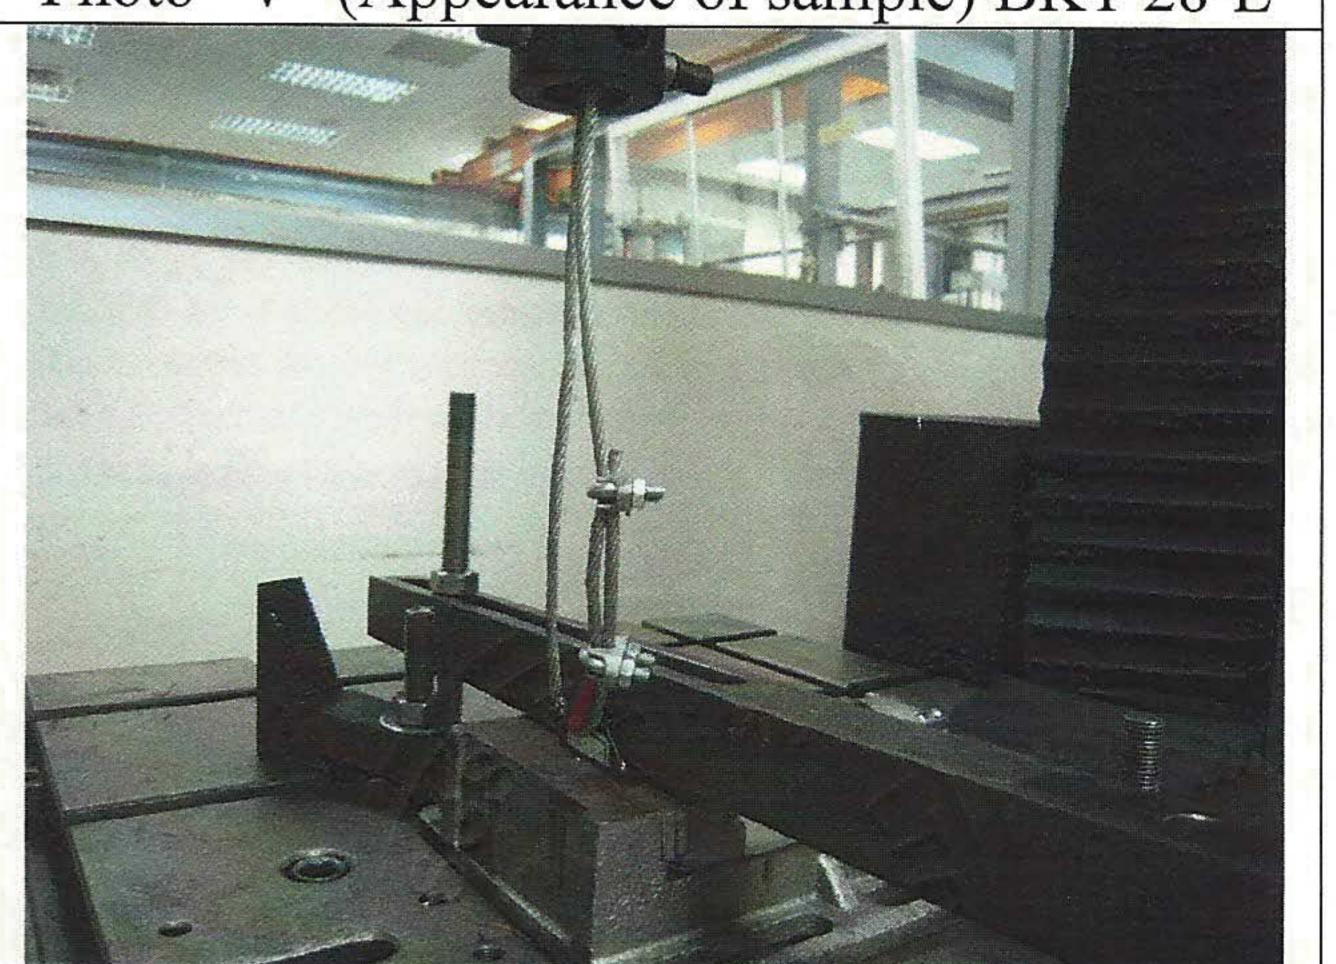
Photo "X" (Test setup)

- 1. Secure the sample on the test platform. (Photo "X")
- 2. Hook a steel cable on the outer edge of protruding shaft, apply an upward load by means of testing machine, until the sample is damaged then record the max force.
- 3. Testing Machine: INSTRON 5581.
- 4. Speed: 10 mm/min.
- 5. Diameter of steel cable: Ø4.7 mm
