TEST REPORT

Report No. : HL60225/2013

The following merchandise was submitted and identified by the applicant as:Product Description: SUPERSEN BRACKETStyle/Item No.: BKT-06DManufacturer/Vendor: SUPER SHENG ENTERPRISE CO., LTD.Country of Origin: TAIWAN**We have tested the submitted sample(s) as requested and the following results were obtained:**Test Requested: Tensile strength test

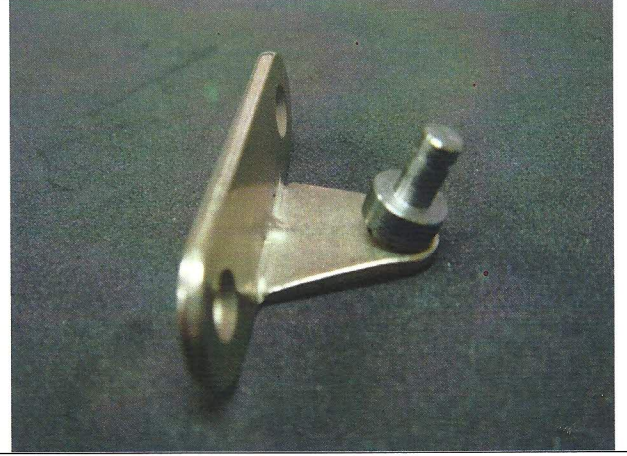
Photo B: After testing

- Test Methods:
1. Hook a steel cable on the outer edge of protruding shaft that is parallel with platform.
 2. Apply an upward load by means of testing machine, until it is damaged then record the max. force.
 3. Testing Machine: INSTRON 5581; Speed: 10 mm/min.
 4. Diameter of steel cable: Ø 3.0 mm

Sample	Max. force (kgf)	Failure mode
BKT-06D	91.8	The sample was deformed after testing (Photo B)
